EVALUATION OF HIGH STRENGTH TUNGSTEN BASE ALLOYS

Charles R. Cook
TRW Inc
Equipment Laboratories

**TECHNICAL REPORT AFML-TR-65-397
NOVEMBER 1965**

**AIR FORCE MATERIALS LABORATORY
RESEARCH AND TECHNOLOGY DIVISION
AIR FORCE SYSTEMS COMMAND
WRIGHT-PATTERSON AIR FORCE BASE, OHIO**

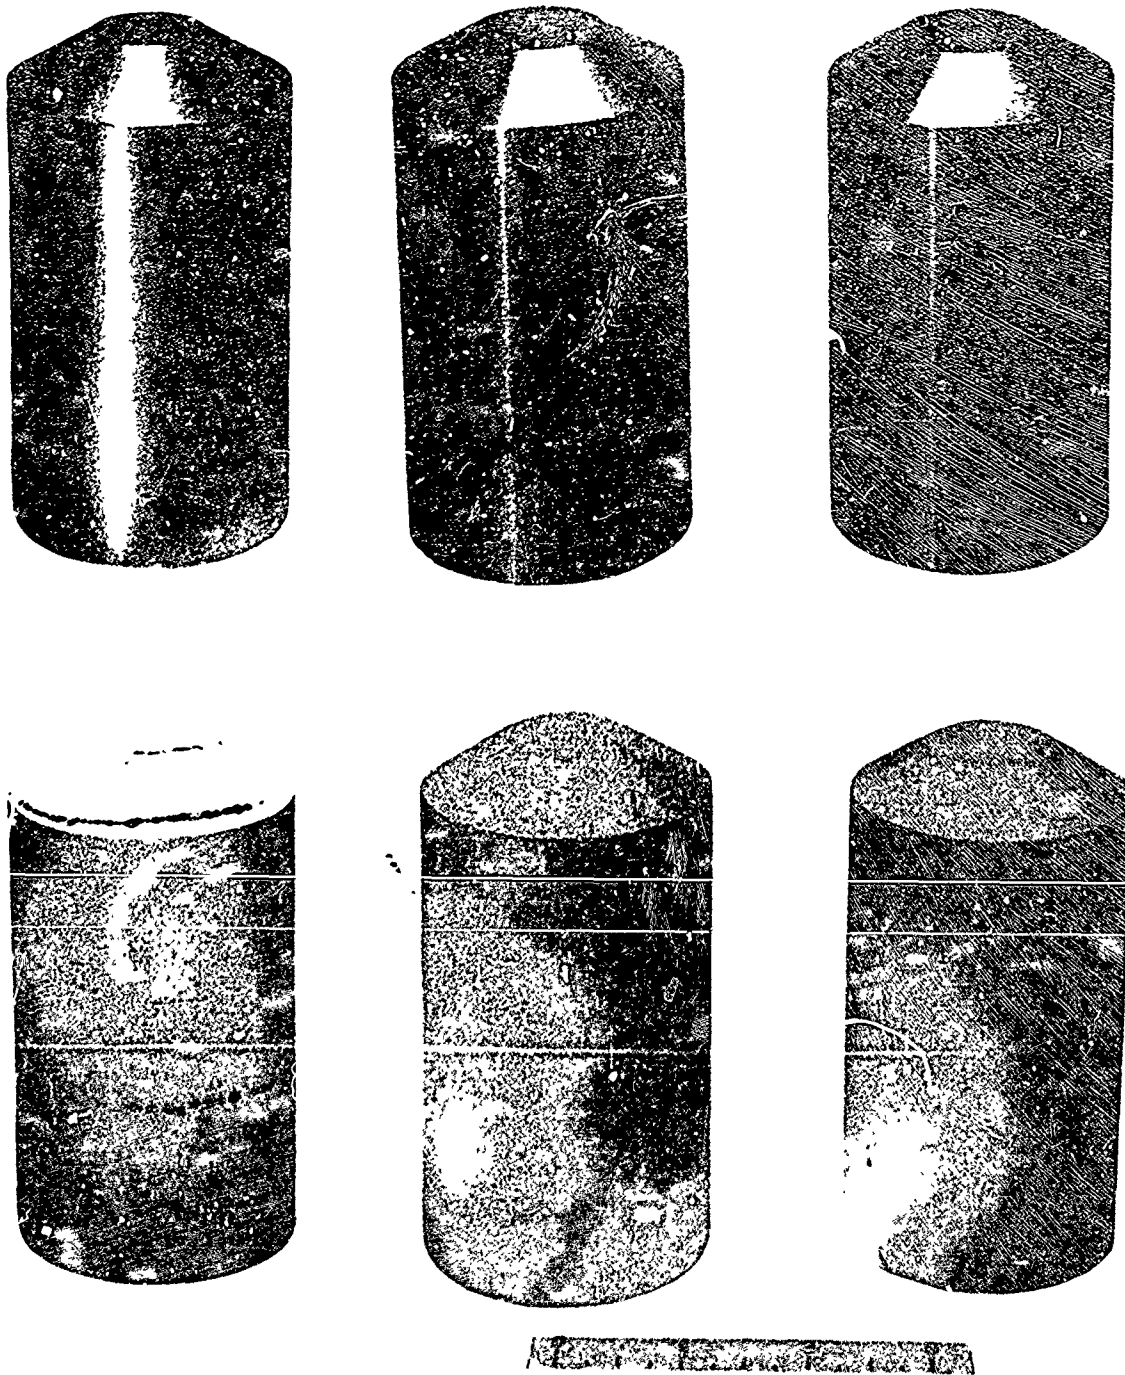
Figure 3. Centrifugal Cast Billets 1A, 2A, and 3A, 68%W-20%Ta-12%Mo.
(a) As Finished Ground, (b) with Die Penetrant Showing Crack Pattern.

Because no extrusion data were available for this alloy it was considered advisable to extrude the ingot to determine pressure, temperature, and extrusion ratio relationships for a guide in processing subsequent ingots. To accomplish this the ingot was machined and ground to its maximum size, 2.5" diameter by 4.25" long. Photographs of the finish ground extrusion billet, both with and without dye penetrant, reveal the cracks encountered (Figure 3).

Ultrasonic inspection of the two billets revealed that both contained cracks, but billet 2A, which was cast in the 1/2" thick graphite mold, had a sound section for 1 3/4" on the end opposite the sprue. These results indicated that this new mold which was designed to reduce the solidification and cooling rates did result in less cracking in the ingots. The two billets, as-ground and with dye penetrant developer, are also shown in Figure 3.

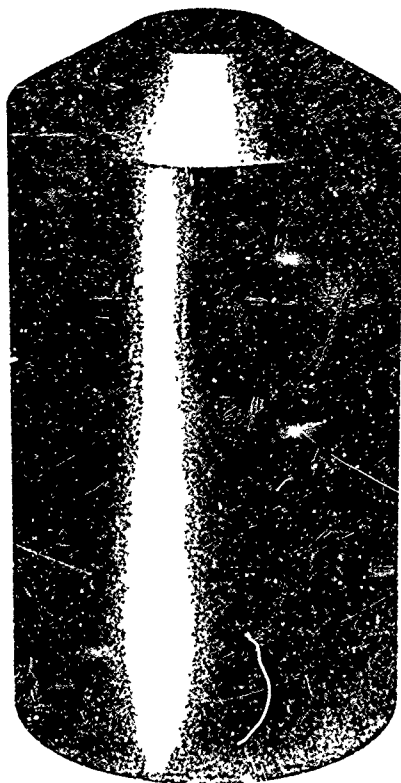
Figure 15. Centrifugal Cast Billet 1A, 68W-20Ta-12Mo. (a) As Finished Ground, (b) With Die Penetrant Showing Crack Pattern.

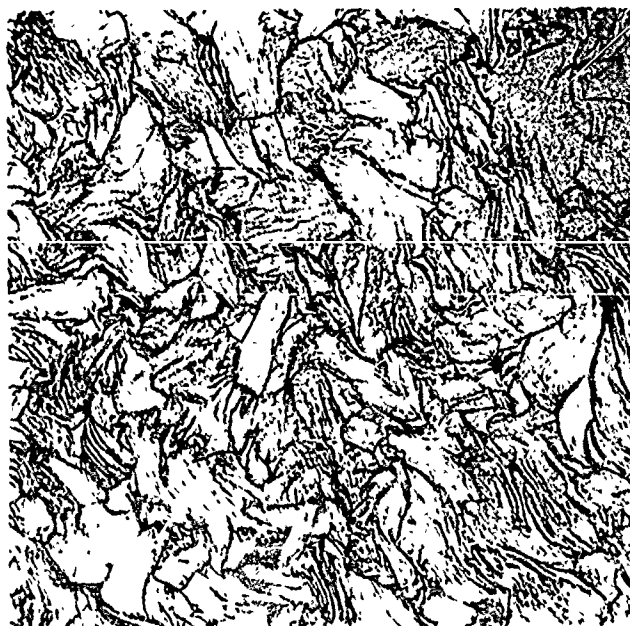
Figure 22. Microstructures of 68W-20Ta-12Mo Extrusions Typical of Both 4A and 5A As-Extruded.

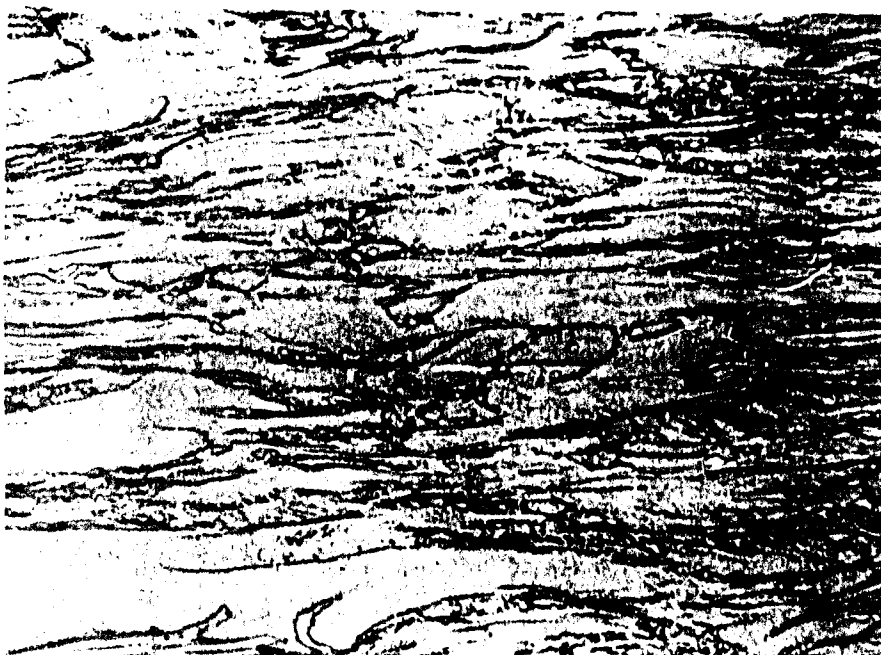
Figure 23. Microstructure of Extrusion 7A, 68W-20Ta-12Mo Alloy
As-Extruded. 100X

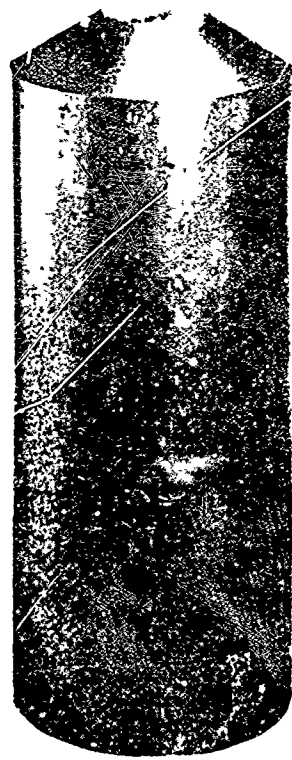
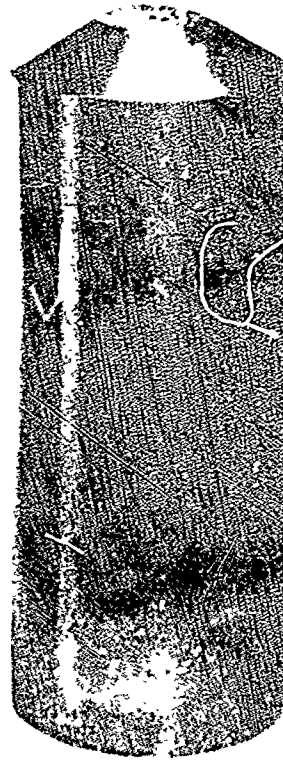
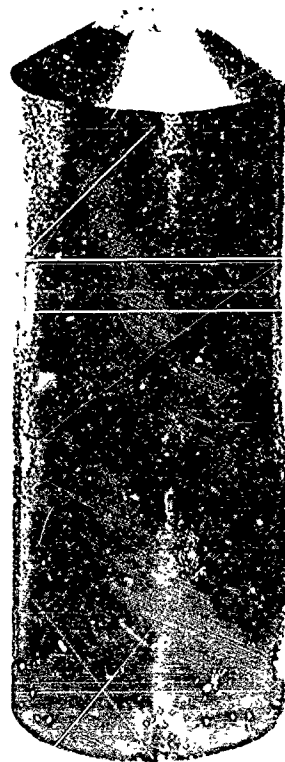
Figure 24. View of Billets 8A and 9A From Both Sides Showing Ultrasonic Inspection Notations on One Side.

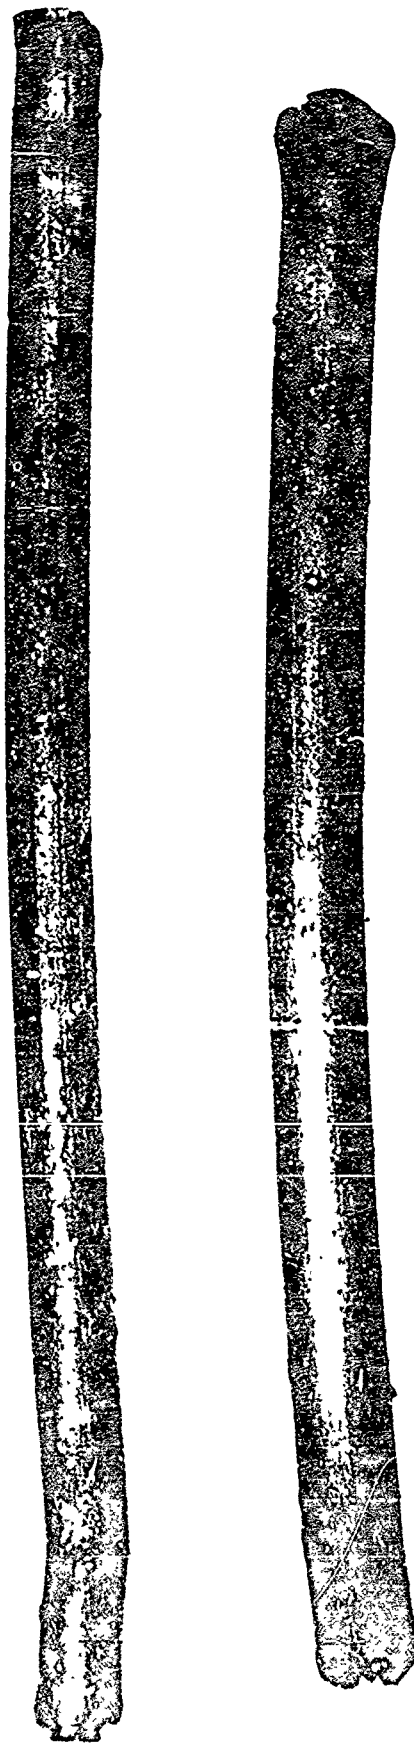
Figure 28. Extruded 10A and 11A of 68W-20T3-1 Mo Alloy.

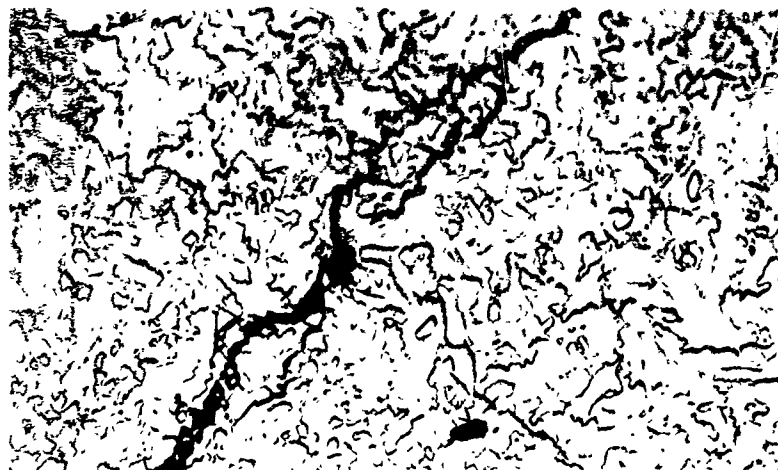
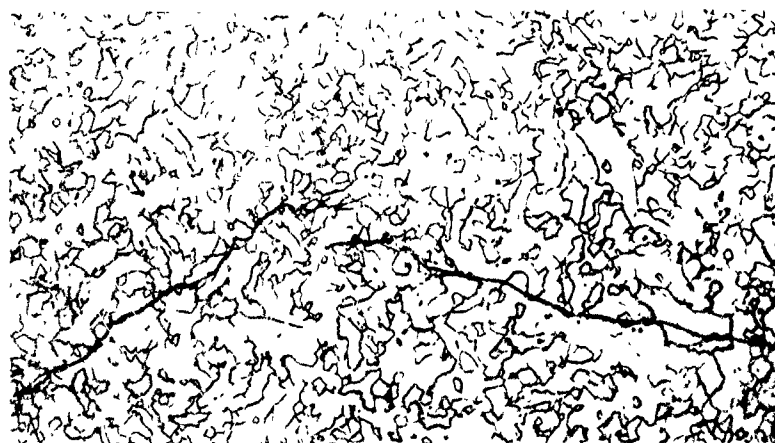
Figure 33. Photomicrographs of Typical Fracture Mode of Sheet Bars Forged Between 2800°F and 3500°F. 100X

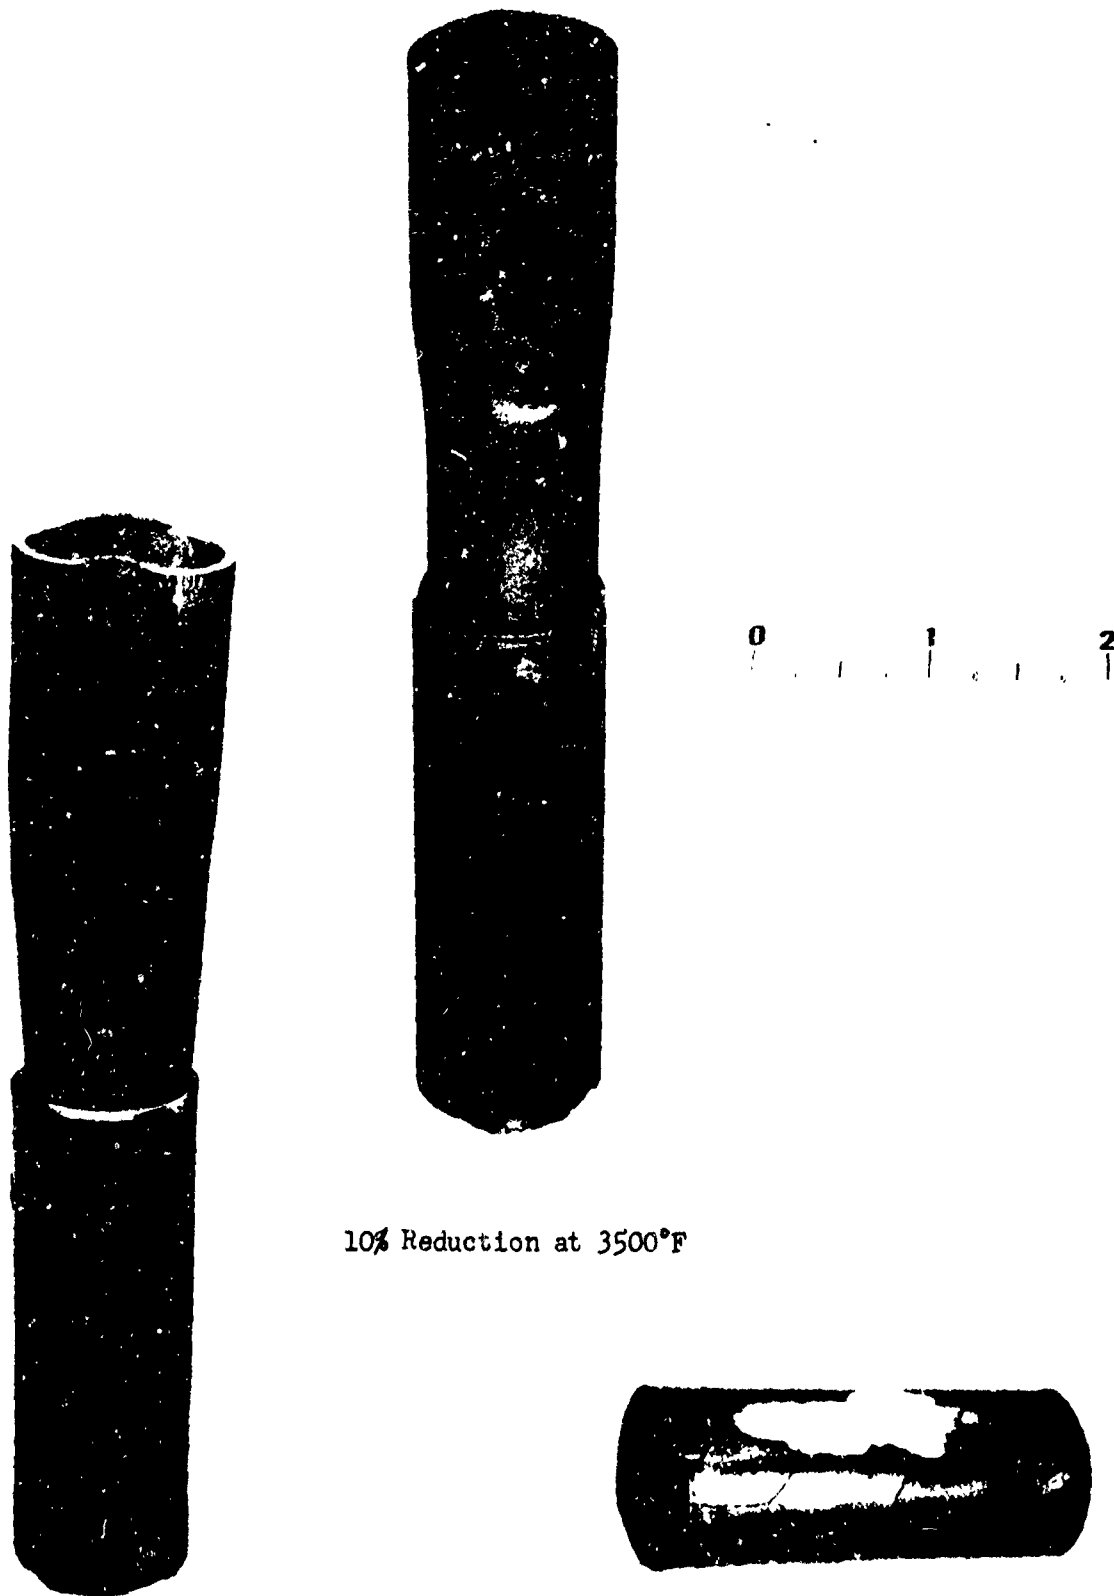
Figure 37. Side Forged Bars of 68W-20Ta-12Mo from Recrystallized Extrusion 10%. Mo-0.5% Ti Cover on Outer Diameter.

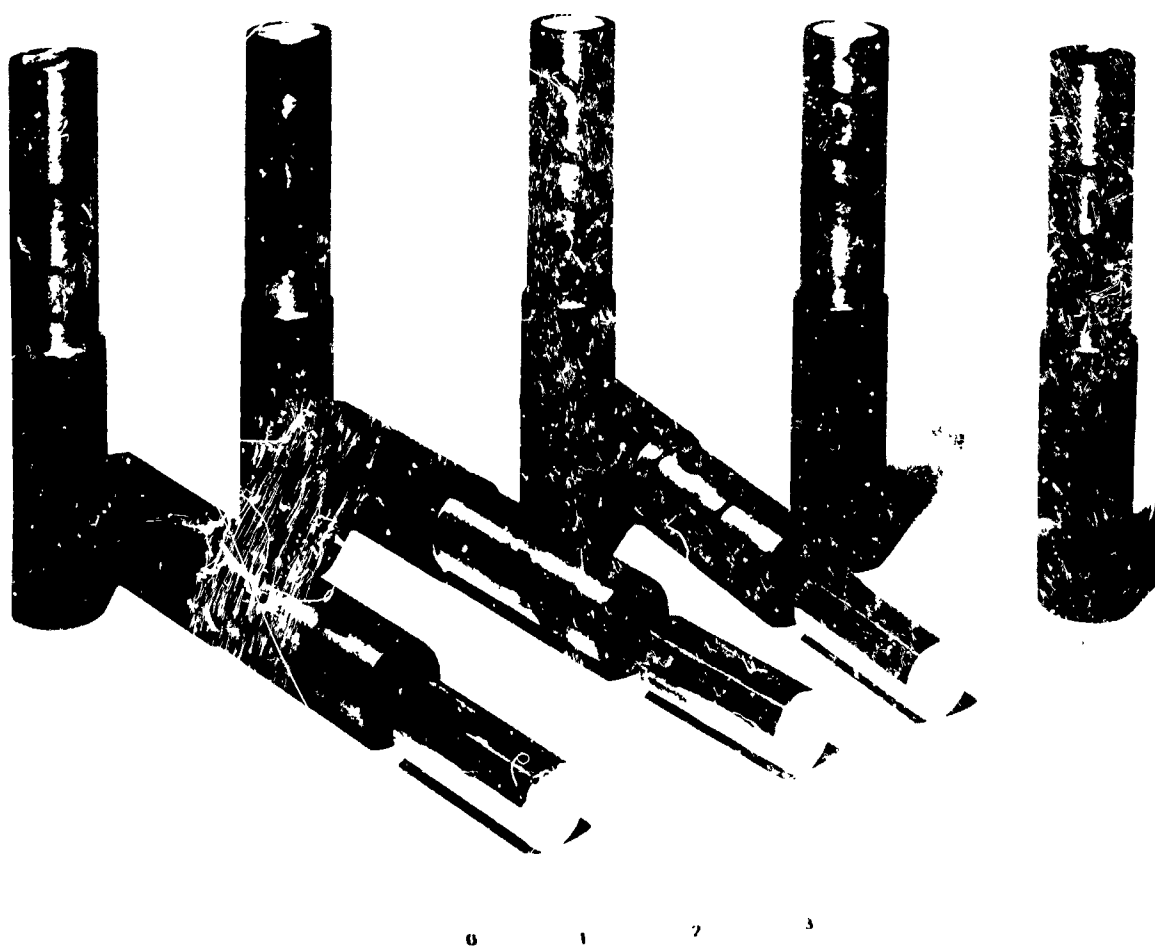
Figure 44. Swaging Samples of 68W-20Ta-12Mo Alloy Prepared From Extrusions 10A and 11A. Bars Were Encased in Mo-0.5%Ti Alloy Bars.

The first sample in the as-extruded condition was induction heated in an argon atmosphere to 3550°F and reduced 20% . After cooling in air, several radial cracks were apparent in the end of the swaged bar (No. 28 in Table VI). The swaging temperature was selected on the basis of ductility data from tensile tests of 11A which, as shown in the following section, indicated good ductility at 2500°F to 3500°F. The loss of temperature in swaging is severe so the higher temperature end of the range was used. Even with rapid transfer from the furnace and in swaging, the molybdenum tube was below red heat after completing the reduction.

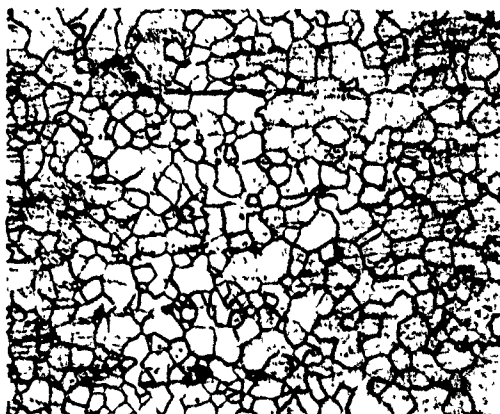
Figure 45. Microstructures of Extrusion 1A After One Hour at the Indicated Temperatures, 100X. Values in Parenthesis are Rockwell Hardness Numbers.

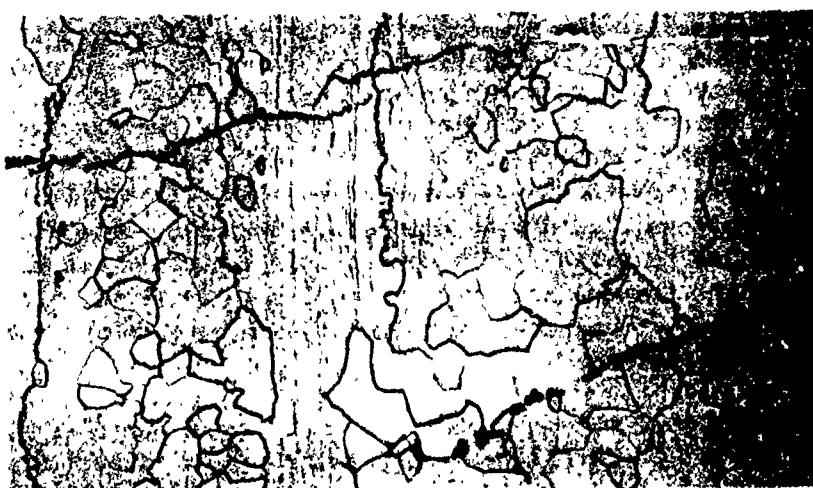
Figure 48. Three Types of Defects Observed in Extrusions of 68W-20Ta-12Mo Alloy Persisting from the Casting or Generated in Extrusion. 100X

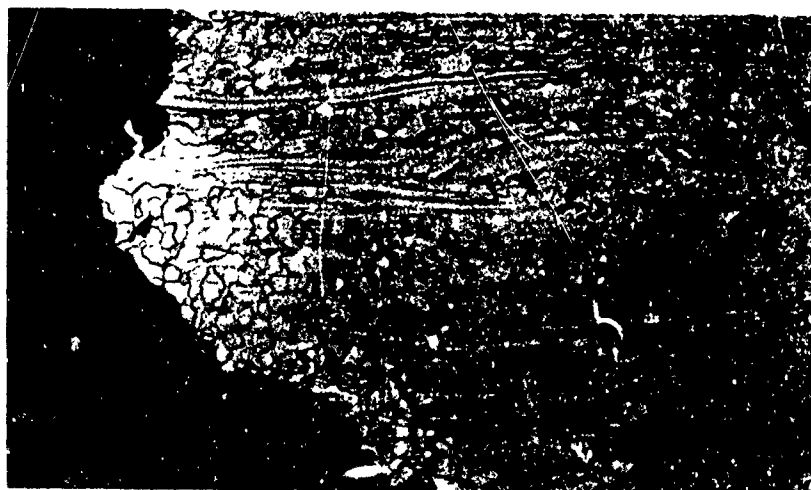
Figure 54. Photomicrographs of Tensile Specimens Tested at 2500°, 3000° and 3500°F for Extrusion 8A of 68W-20Ta-12Mo Alloy in the Wrought Condition. 100X

2. The increase in ductility in the region from 2500 to 3000°F is reflected in the marked elongation of the individual grains, especially near the fracture surface. Fractures are mainly transcrystalline and necking is marked.

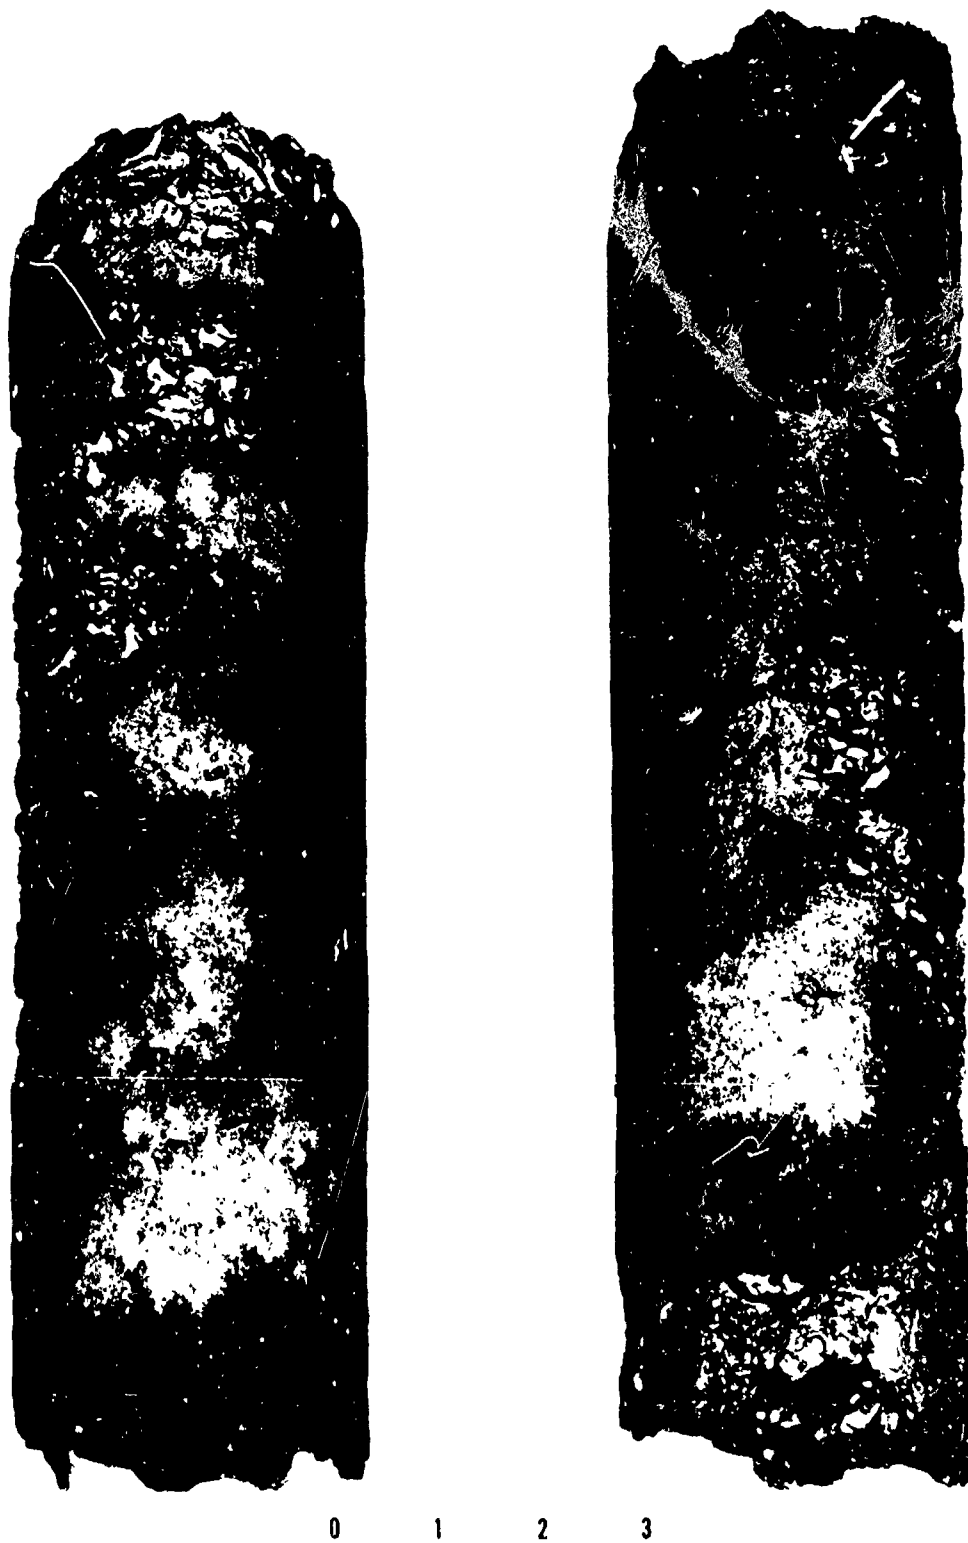
Figure 59. Photographs of the AC Arc Melted Ingots of the W-12Cb-0.29V-0.12Zr-0.07C Alloy in the As-Cast Condition.

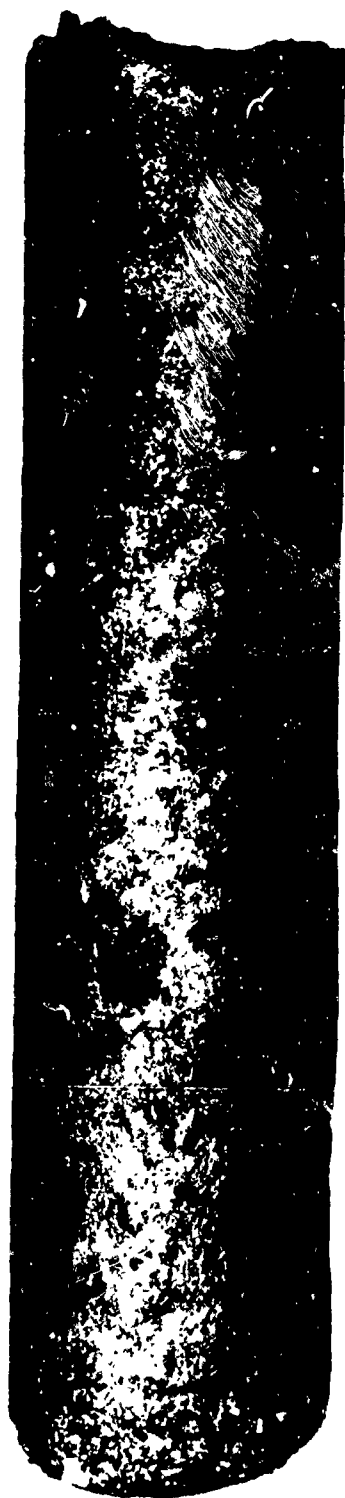
Figure 60. Ingot No. 3 of the W-12Co-.29V-.12Zr-.07C Alloy as
AC Arc Melted with W-15Mo Sections on Top and Bottom.

In an effort to obtain sound material another ingot was melted with sections of W-15Mo on top and bottom sections. It was theorized that the more ductile W-15Mo alloy on the top and bottom of the ingot would reduce the cracking tendency in the starting pad and hot top areas during solidification and cooling. This ingot is shown in Figure 60 with the macroetched top and bottom sections which were removed from the ingot. It is apparent that the W-15Mo sections did not provide the desired prevention of cracking.

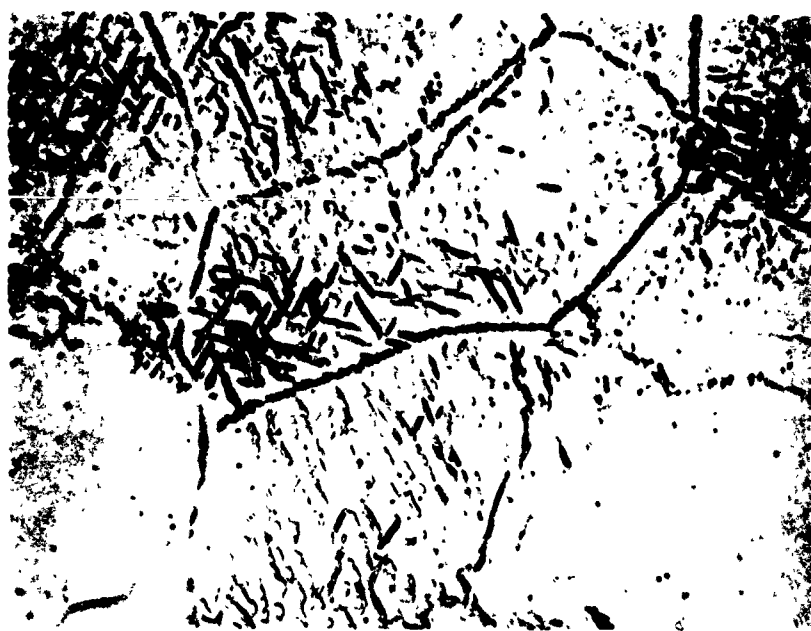
Figure 61. As-Cast Microstructure of W-12%Cb-0.29%V-0.12%Zr-0.07%C Consumable Electrode Vacuum Arc Cast Ingot.
